AltaLink 54L Transmission Line Rebuild in Banff National Park: Detailed Impact Assessment DRAFT

**Parks Canada Agency
Banff National park**

July 7, 2025

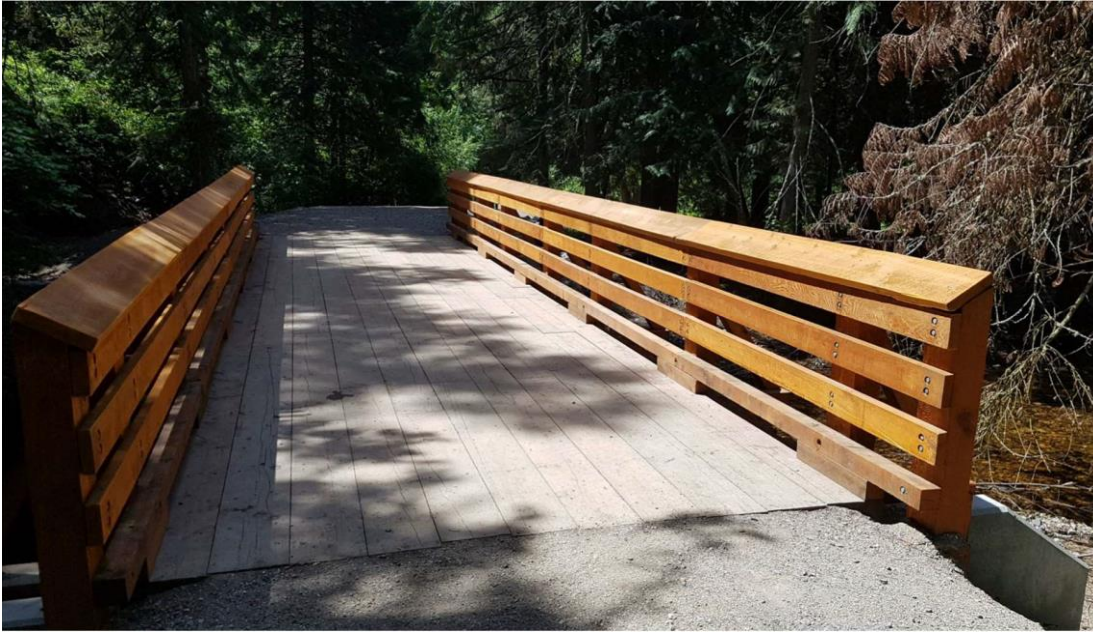
At the Anthracite crossing (Johnson Lake outlet), the existing pedestrian bridge will be replaced by a wider, machine-accessible permanent bridge with new, engineered abutments. The existing pedestrian bridge superstructure will be removed by a crane and an excavator. The existing concrete abutment and weir will remain in place to avoid erosion and sediment release downstream. The area behind the existing abutments will be excavated and the new abutments for the wider bridge will be built higher than the existing abutments. If required for aesthetics, riprap may be installed to conceal the existing abutments. The new superstructure will be installed using a crane and an excavator. All work will occur above the HWM except for the one-time ford by an excavator to remove the old pedestrian bridge and install the new bridge. The new bridge will be at least 40 feet x 14 feet; the proposed design will be similar to Figure 1-1. This bridge will be used by all machinery and vehicles for access to structures east of structure 264 during all Project activities, as well as future operations and maintenance of the 54L transmission line.

Figure 1-1. Potential bridge design for replacement of the pedestrian bridge across Johnson's Lake Outlet.

3d	195	Very steep cut and fill between str 242-244	Cut and fill on bottom 1/3 of slope to reduce slope on existing access
4a	70	Across Johnson Lake outlet at west end of lake	Replacement of existing pedestrian bridge across the outlet with a wider bridge to accommodate machinery
4b	1028	Existing gated access road from the Johnson Lake day use area parking lot	Nothing required

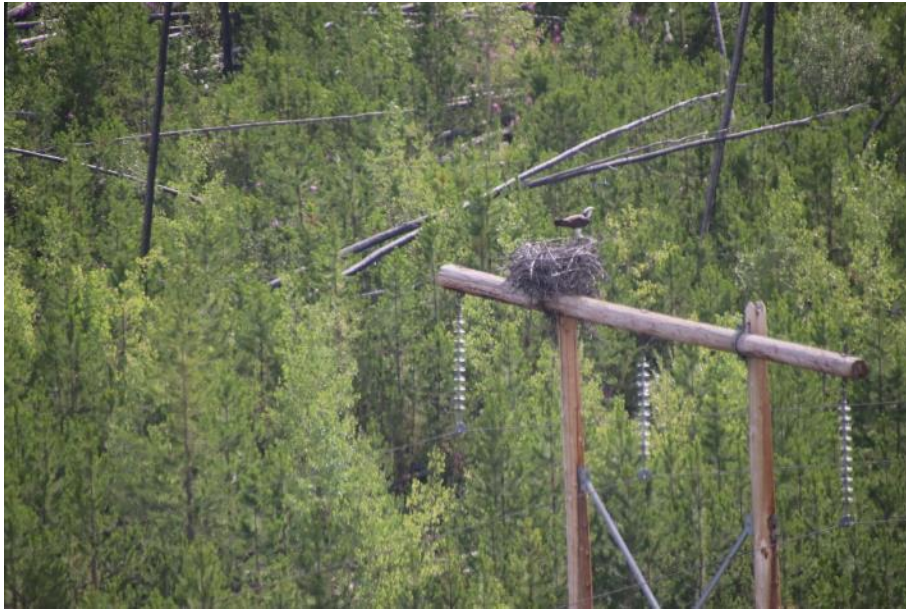
Figure 5-10. Osprey pair (mate is absent) with established nest on Structure 222.

Two active osprey nests were detected within the ROW; one osprey pair were sighted on, and flying around, a large stick nest built on structure 222 (no young; Figure 5-10, Appendix A). The other active nest contained one adult and two young sitting on a large stick nest adjacent to structure 276 on a Fortis structure (Appendix A). A falcon *sp.* was also observed flying northeast of structure 266 during the aerial raptor survey, but no nest was located.
